# Project Profile Data

Pieso Poagen, Nine Mile Falls, Washington, WA, USA

System Build-up:  
"Sloped Green Roof" with Georaster®  
and Floradrain® FD 40-R

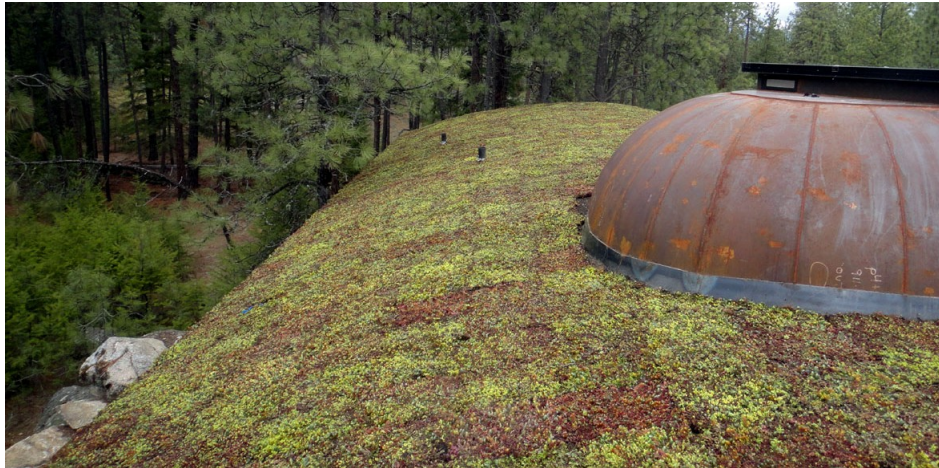
*The green roof integrates the building perfectly into its surroundings.*

This high end residential green roof is broken up into 3 separate areas. The roofs are all barrel shaped with slopes in excess of 30 degrees. There is a custom fabricated steel parapet wall that encloses the entire green roof build-up. On the steepest slopes (the bottom of the roof edges) the parapet wall is perforated with 1" (25.4 mm) slots that feed to an internal gutter system to insure consistent drainage away from the exterior walls.

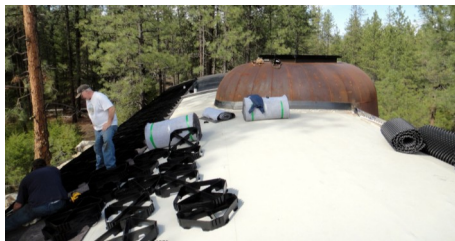
*In the steeper areas the Georaster®-elements have been placed on the Water Retention Mat WSM 150, starting from below.*

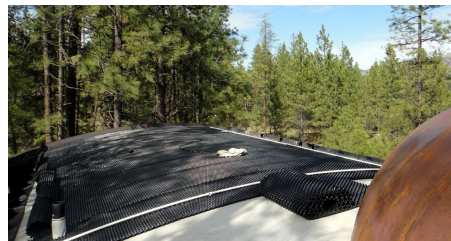
*In the flatter areas above the Georaster®-elements Floradrain® FD 40-R have been installed.*

The ZinCo Georaster® system stabilizes 5" (127 mm) of extensive growing media on the steepest sections of the roof and rolls of Floradrain® FD 40-R were used on the "top of the roof barrels" where stabilization was less important, but water retention was critical. The roof utilized pre-cultivated sedum mats that provided nearly 100% coverage on the day of installation and will continue to flourish with a variety of colors as the roof ages.

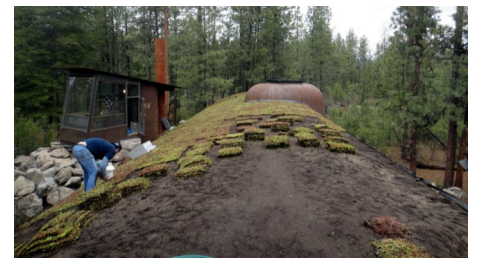
*In order to obtain a complete green coverage immediately pre-cultivated vegetation mats have been applied on the growing media.*

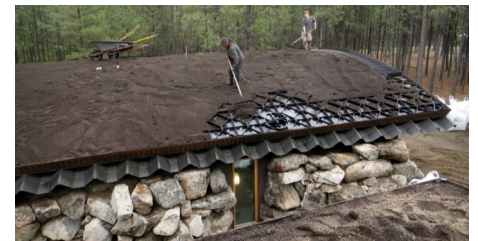
*In the next step the drainage elements were completely filled with the growing media.*
